AN OASIS FOR RAILROADERS IN THE MOJAVE
The History and Architecture of the Los Angeles and Salt Lake Railroad Depot,
Restaurant and Employees' Hotel at Kelso, California, on the Union Pacific System

Kelso Depot Historic Structure Report

National Preserve • California

January 1998

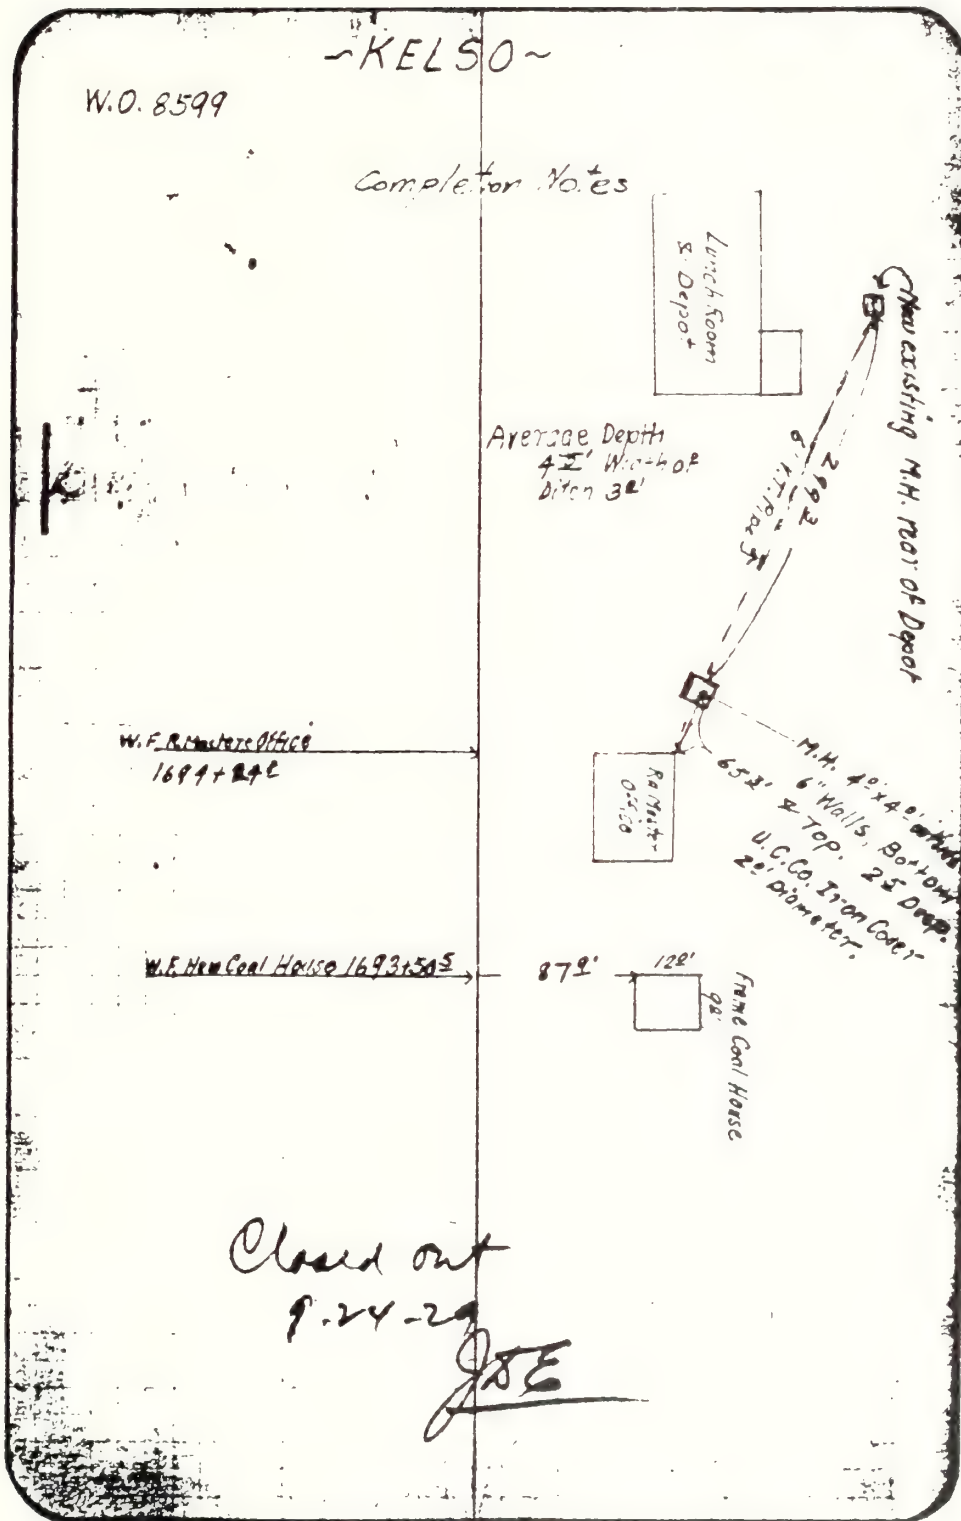
Figure 11: Field Engineer's sketch plan for a pipe and manhole behind the depot, which was closed out (completed) on September 24, 1929. Credit: Union Pacific Museum Collection.

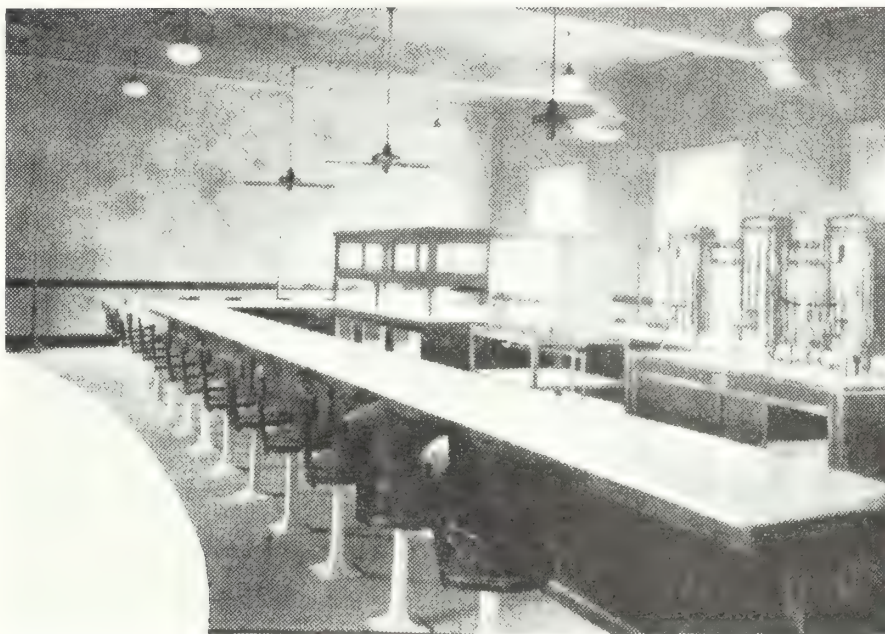
Photo 22: The Caliente, Nevada, depot lunchroom, *The Union Pacific Magazine*, Vol. 1, No. 11, November 1922, page 58. The Kelso lunchroom and counter were probably similar except that the U-shaped counter was not as long and had fewer stools.

Subsequent to receiving Art Francis' description of the original counter and stools in the Kelso Lunch Room, the author of this study found in *The Union Pacific Magazine*, Vol. I, No. II, November 1922, p. 58, a montage of five photographs of "Our new Depot-Hotel at Caliente, Nevada." The upper right photo showed a lunch room at Caliente which had a somewhat larger apparently U-shaped counter than the one at Kelso, and it seems a reasonable inference that the counter, stools and other furnishings were similar except in size to those built at Kelso in late 1923 and early 1924. Confirming Art Francis' statements, the Caliente lunch room counter had a shiny bright white top and the stools had T-shaped backs, and posts finished in white paint or enamel that tapered out at the bottom onto a square base affixed to the floor. Circumstantial evidence in this case, or perhaps it might be termed comparative evidence, seems to confirm the accuracy of Francis' statements.

Still later in the research for this report, documentation for rearranging the counter and stools and other remodeling in the Kelso Lunch Room found in Union Pacific files in Los Angeles, and the project had begun in 1948 just when Art Francis thought it had, although the actual work was not done until the summer of 1949. It is not clear whether the present linear counter is made up of parts of the old "U"-shaped counter, or is an entirely new piece of restaurant furniture, although it is likely to the author of this study that it was made up of parts of the original counter, although it no longer has its original white top. Railroads did like to recycle materials.

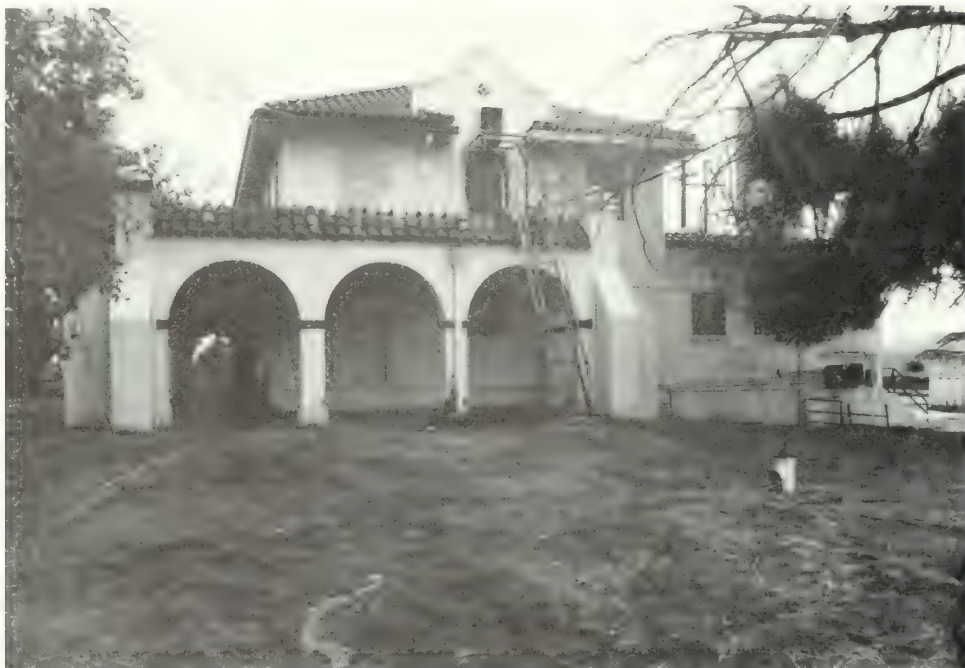
Photo 25: Northeast end of the depot showing the fire escape ladder that had been salvaged and recycled from the power house, installed here in 1960. Photo September 2, 1991 by John W. Snyder.

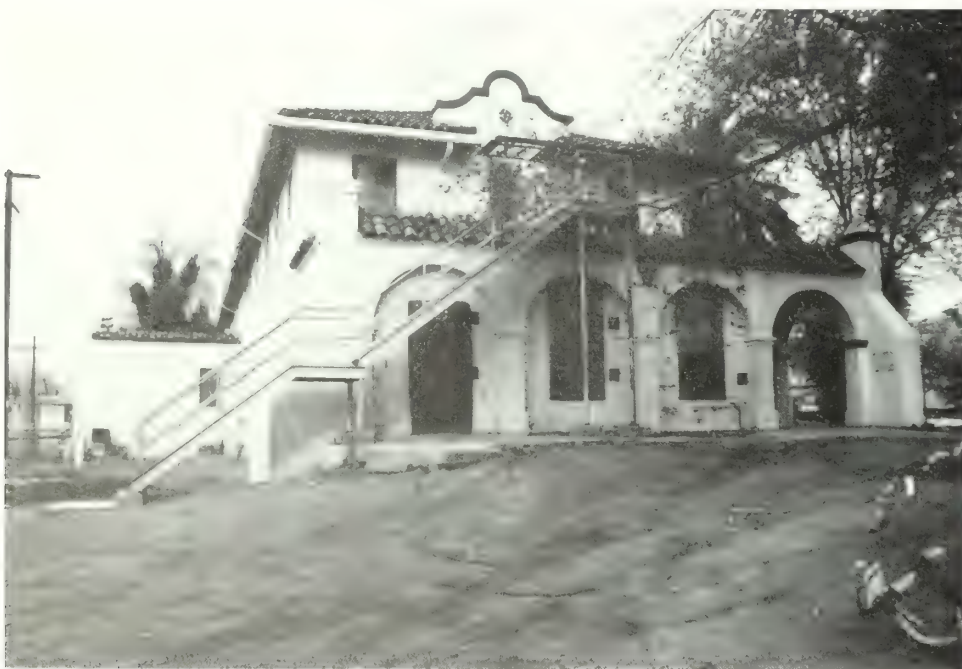
Photo 26: Southwest end of the depot with the fire escape constructed in 1961 still in place on September 2, 1991 when this photo was taken. The fire escape stairs were removed as part of a BLM contract in 1993. Photo courtesy John W. Snyder.

being too steep, the ladder being too narrow, and not having a landing at midpoint. During the first half of 1961, probably mostly in April, May, and June, the railroad constructed a stairway, not ladder, with landing and railings, to serve as a fire escape outside the southwest end of the depot, the end window upstairs being converted into a door, and a runway being constructed across the roof of the arcade to connect the door and ladder.²⁴⁷

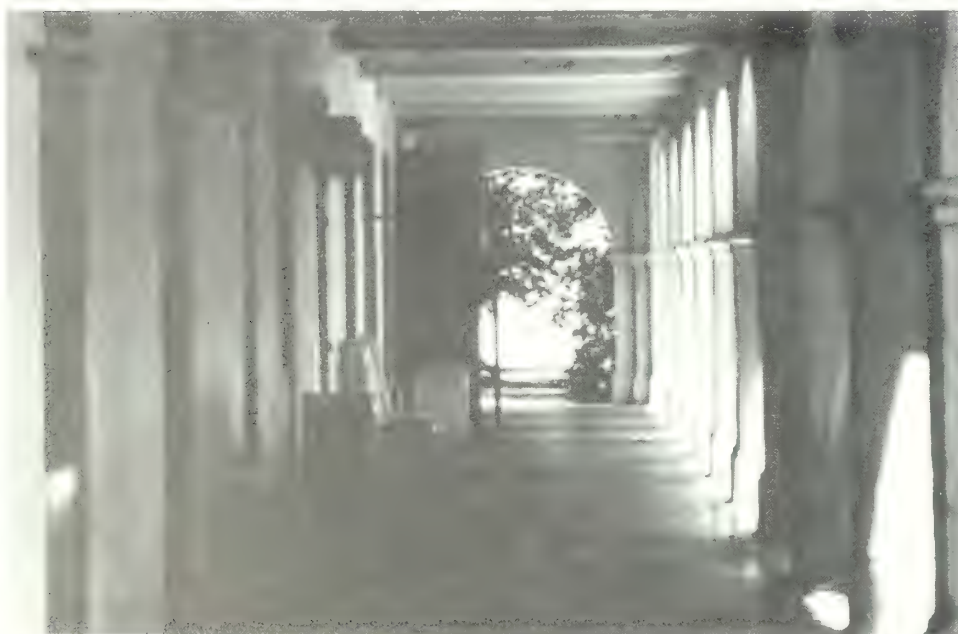
Photo 28: By 1960 the railroad had installed air conditioners in the transoms over the doors from offices onto the arcade, and a large evaporative cooler near the phone booth which cooled the lunch room. The bench on the arcade had originally been at the west wall of the Conductor's Room or waiting room at the west end of the depot. Photo courtesy collection of Art Francis.

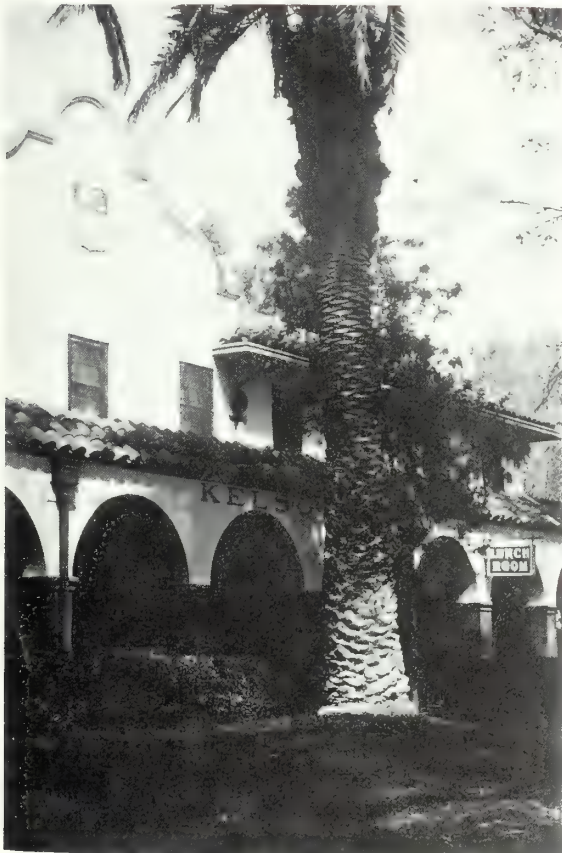
Photo 32: For a number of years up to the March 16, 1974, date of this photograph, the columns below the springlines of the arches were painted a dark green, as were portions of the drain pipes. The "Overland Route" language stretched diagonally across the Union Pacific shield had been expunged at that time. Photo by Steve Patterson.

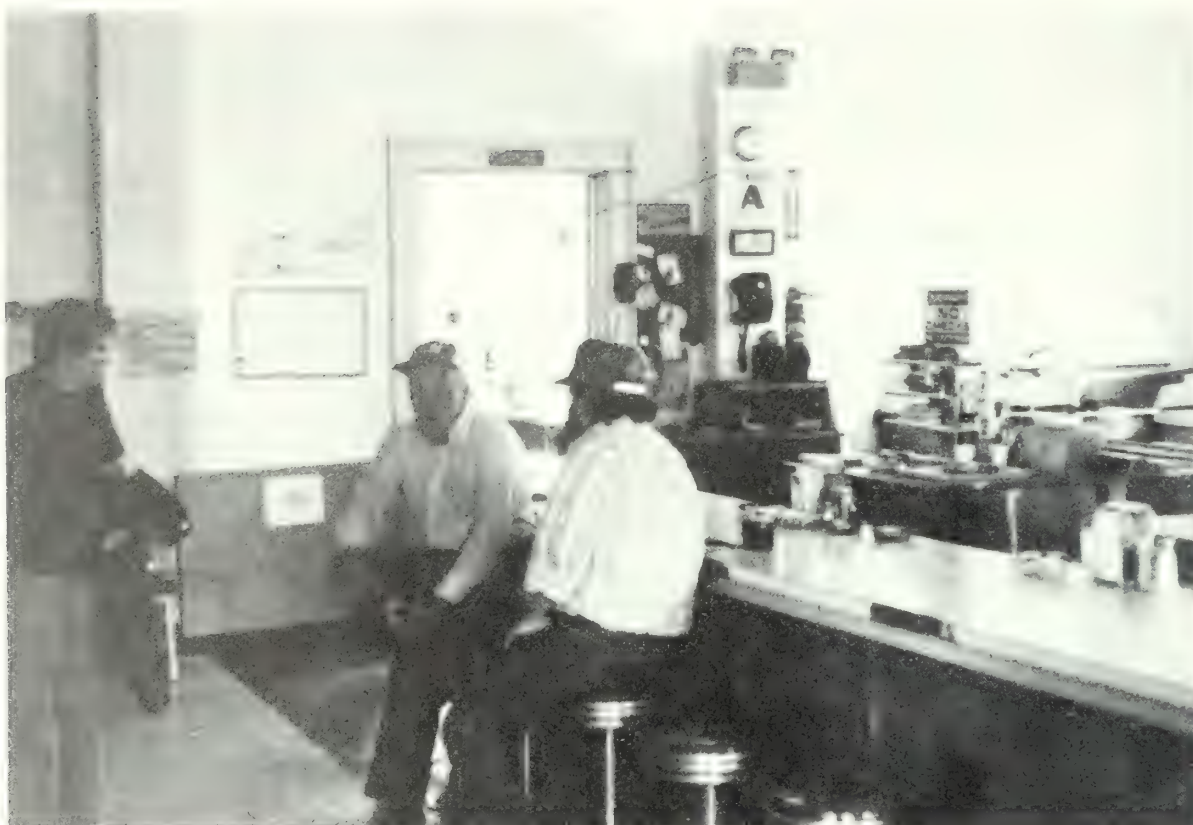
Photo 39: The Lunch Room, ca. 1960, showing the 1949 and 1955 modifications, including the lunch counter, stools, and doorway to the kitchen. Photo by Art Francis.

The comfortable room no longer accommodated separate tables. A wide counter with small stools divided the few customers from new stainless steel refrigerators and a hooded hot plate for short orders. But the dishes were of another era, inscribed with the "Challenger" logo from famous Union Pacific transcontinental passenger limiteds.

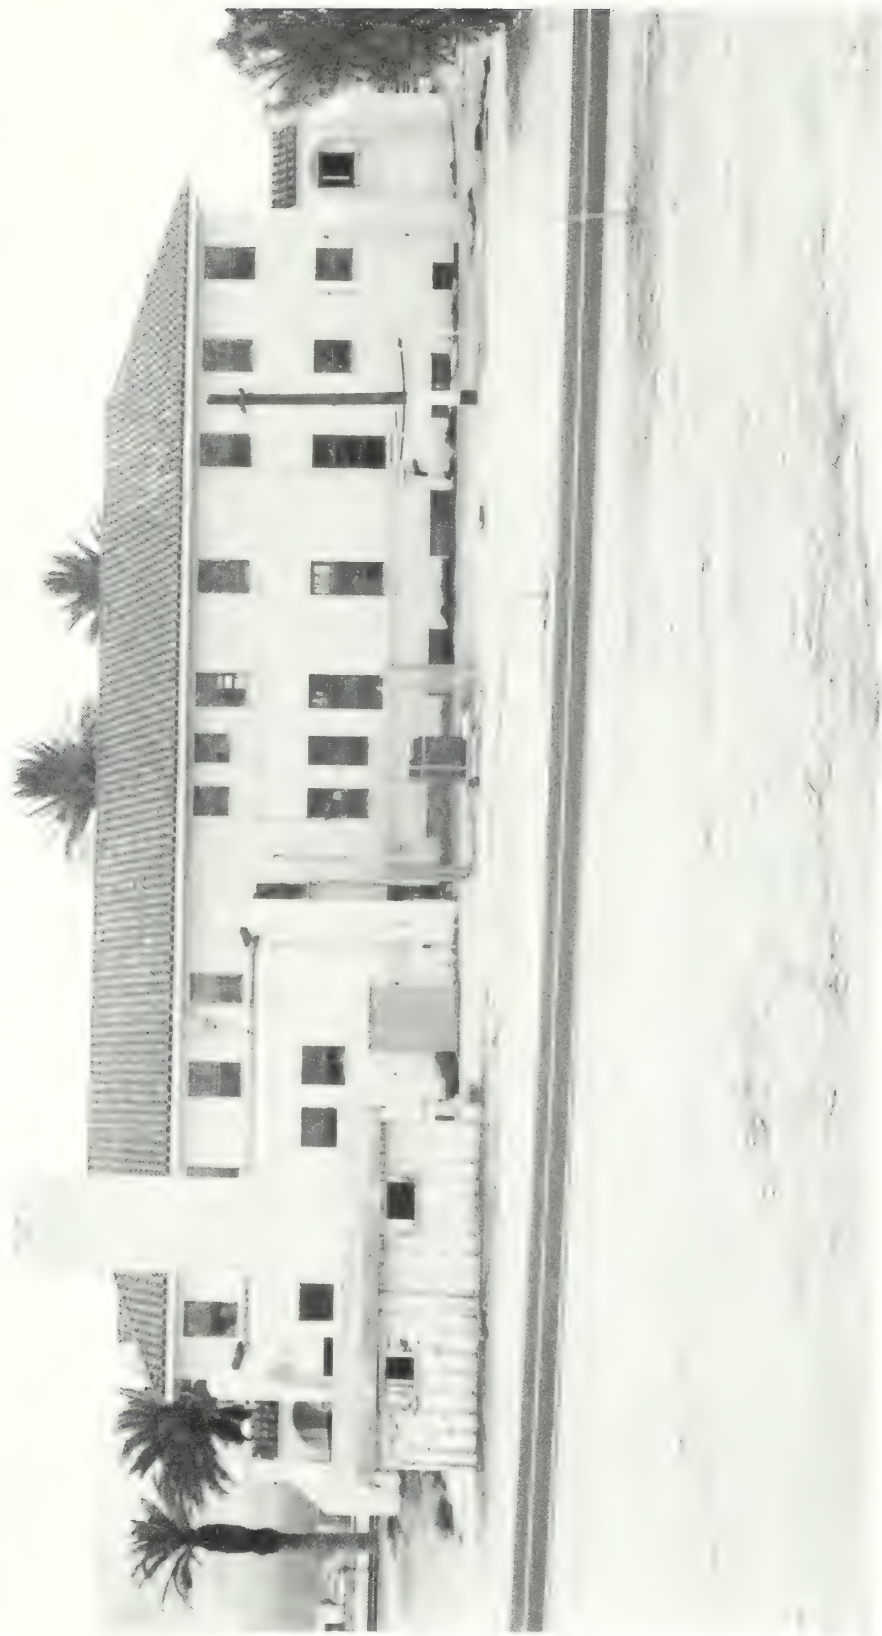
Photo 46: View of rear of Kelso Depot building and site. The small building behind the kitchen, at left, is the coal and storage shed. Photo by Gordon Chappell, NPS, February 8, 1995.

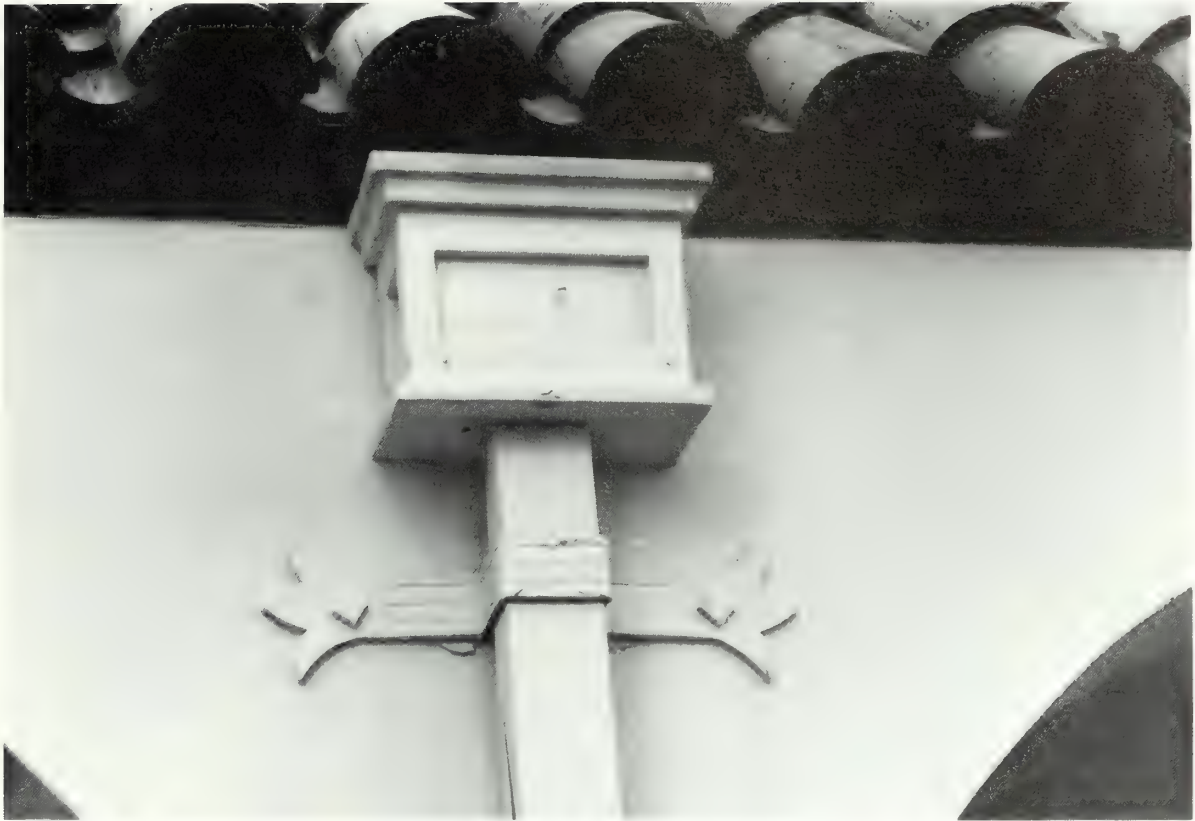
Photo 48: Detail of downspout collection box (gutter is missing) and downspout strap. Photo by John W. Snyder, September 2, 1991.

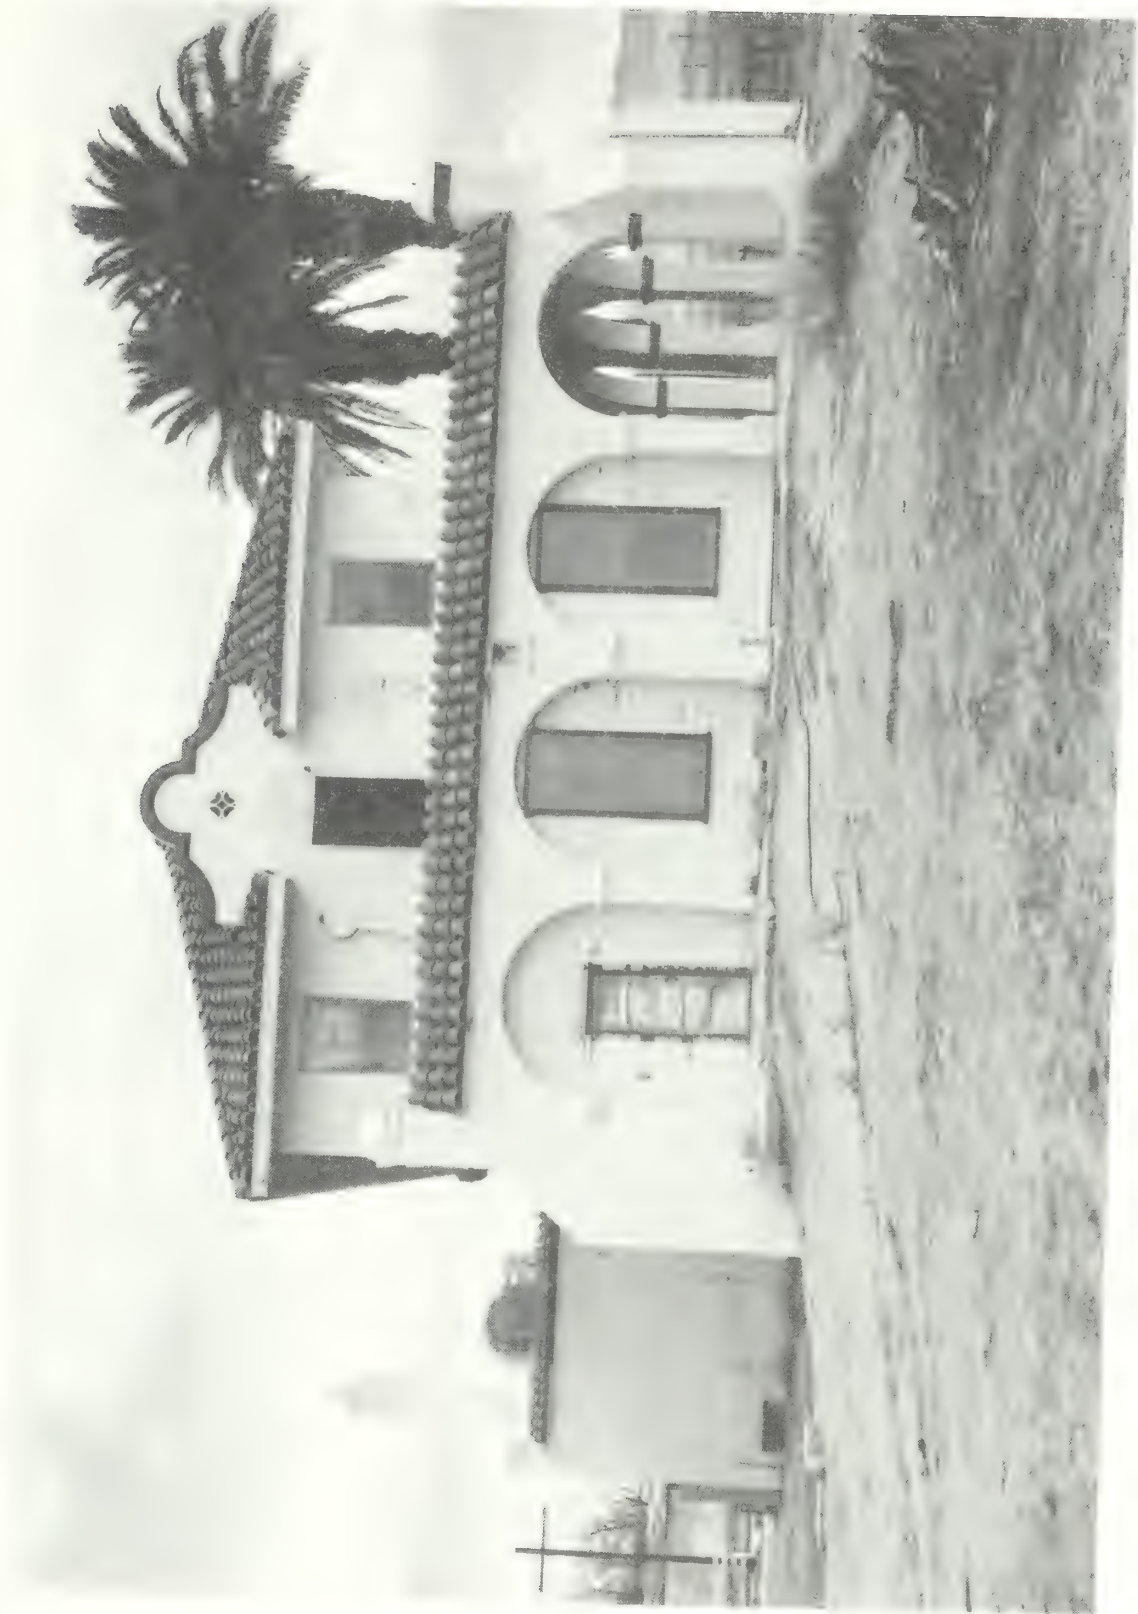
Photo 51: Southwest elevation of the depot showing the 1942 enclosure of the arcade at this end of the building to create an additional baggage and express room. Photo by Gordon Chappell, NPS, February 8, 1995.

West Addition — The addition in the west arcade was probably constructed in 1942, although the exact date and purpose have not yet been confirmed. Some sources indicate there was need for shop space by the railroad; other sources indicate the addition to have been caused by the hectic World War II and mining activities. As described in the historic data, this addition was most likely constructed for a baggage room because the original baggage room was converted to the station

agent's office. The west three bays of the arcade were enclosed simply by in-filling the arches and north and south ends of the arcade with wood frame walls and sheathing the exterior with horizontal siding and the interior with plywood. The exterior siding is 1x8 v-groove shiplap so that the surface has an appearance similar to the arcade ceiling, although that original material is tongue and groove and the edge profile presents a wider, deeper groove. The original ceiling of the west arcade was not altered, nor was the concrete floor slab.

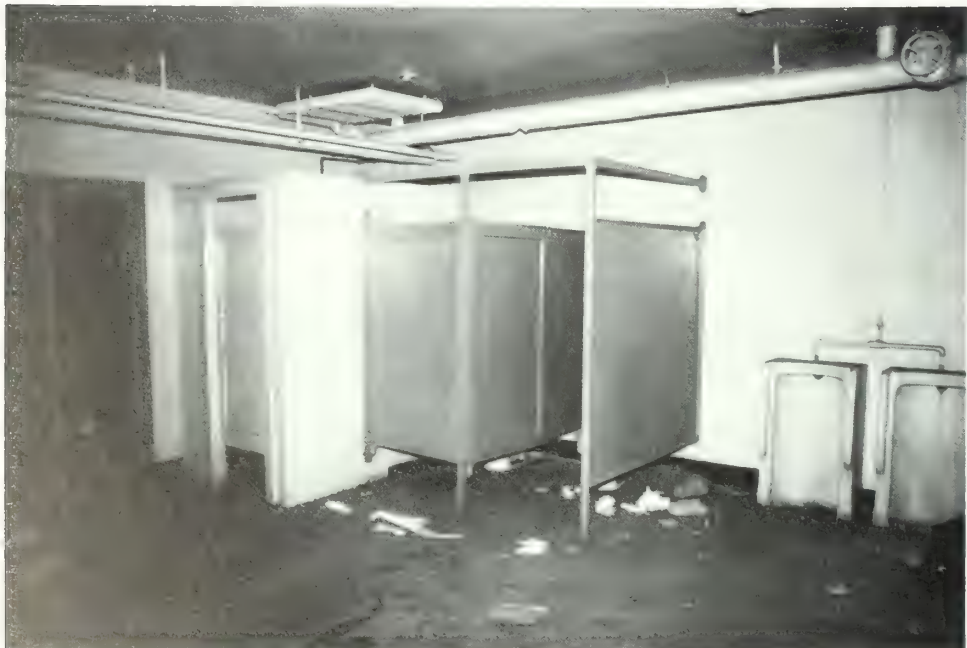
Photo 53: The historic Basement Toilet Room, with the original wooden shower stall, at left, metal toilet stalls and urinals. Also note the steam radiator hung from the ceiling. Photo by John W. Snyder, September 2, 1991.

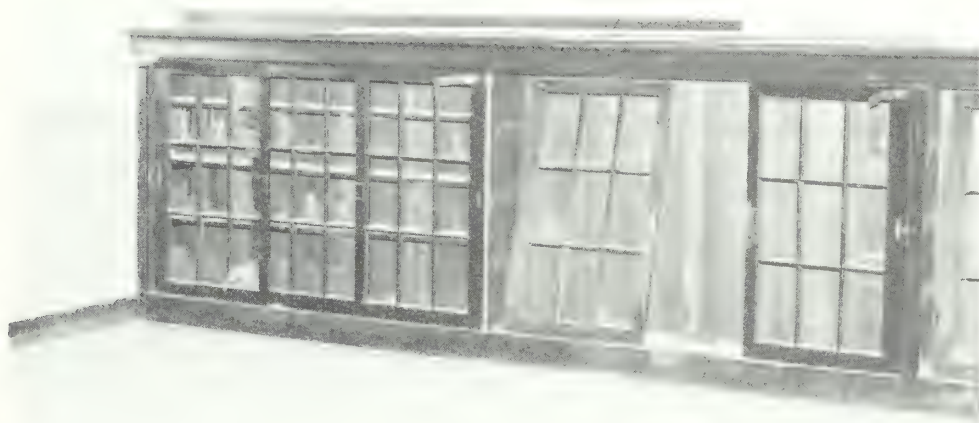
Photo 55: The original bookcases in the Reading Room. Photo by R. L. Carper, 1997.

A wood and glass historic bookcase remains along the west wall of the Reading Room. It has been badly vandalized--all the door glazing is broken-- but it is repairable.

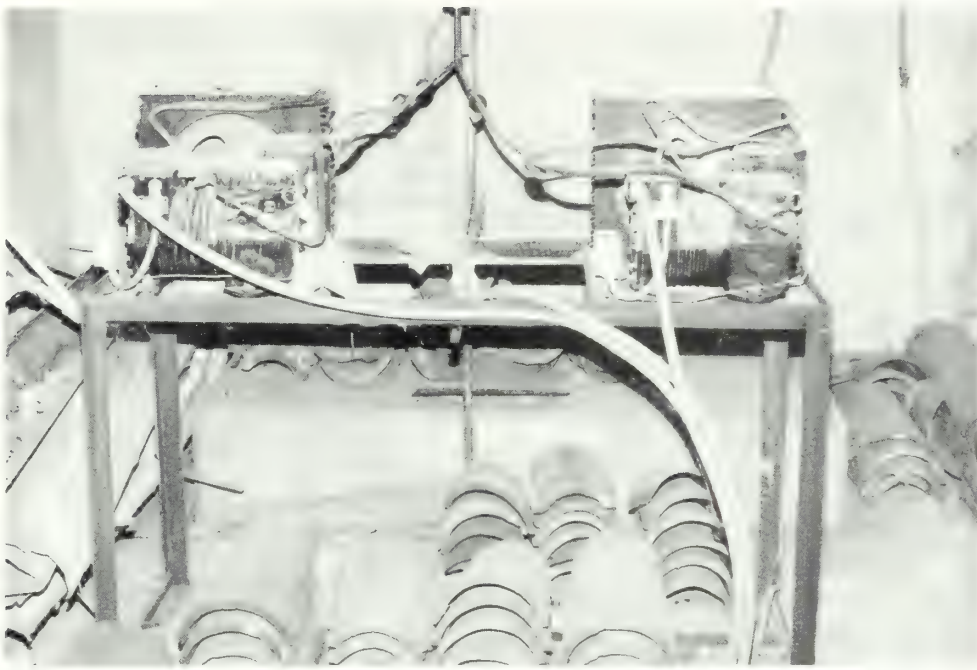
Photo 56: Originally planned as a basement Storeroom, in the northwest corner of the Kitchen wing, this refrigeration equipment was probably installed here ca. 1925 instead of on the first floor adjacent to the freezers. Photo by R. L. Carper, NPS, 1997.

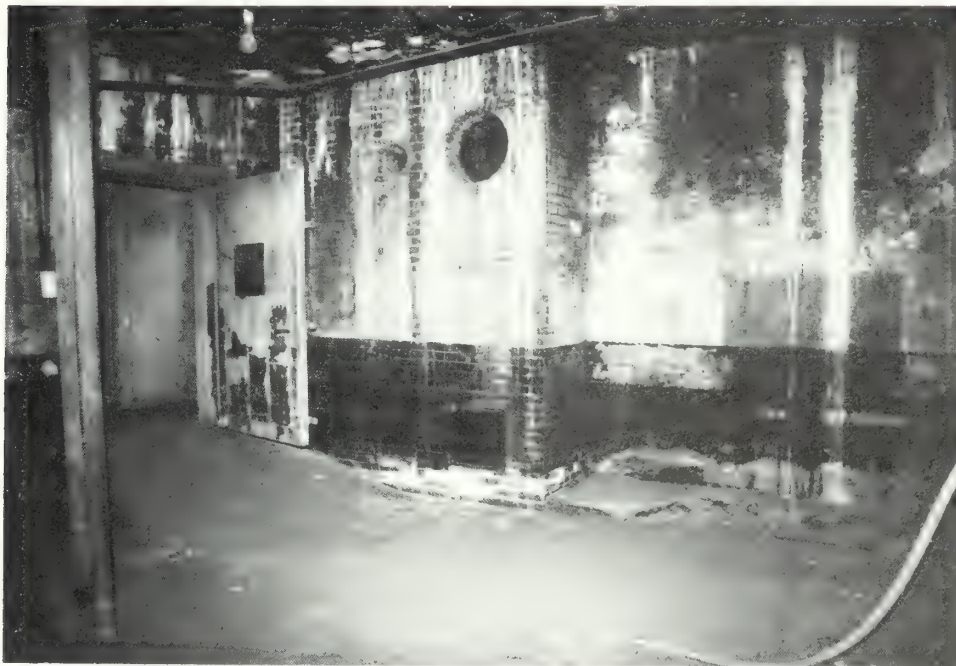
Photo 57: Basement Boiler Room. Note fire door, a wooden door sheathed with sheet metal, with original hardware. Photo by John W. Snyder, September 2, 1991.

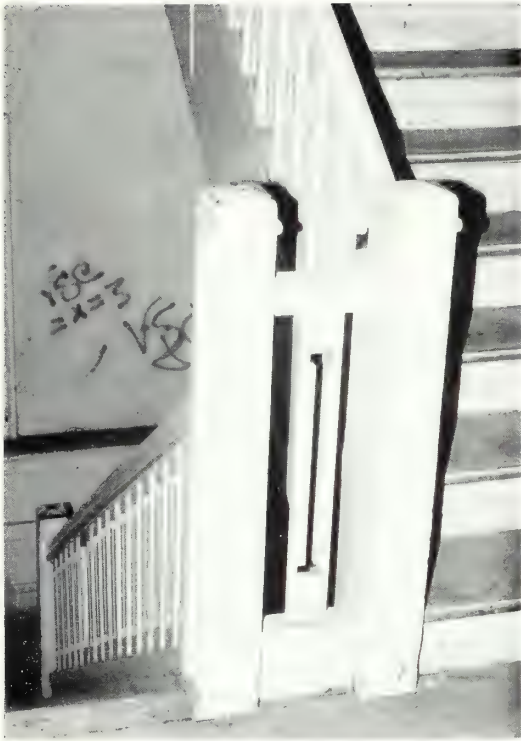
Photo 59: Main staircase from lobby/Lunch Room to second floor. Photo by R. L. Carper, NPS, 1997.

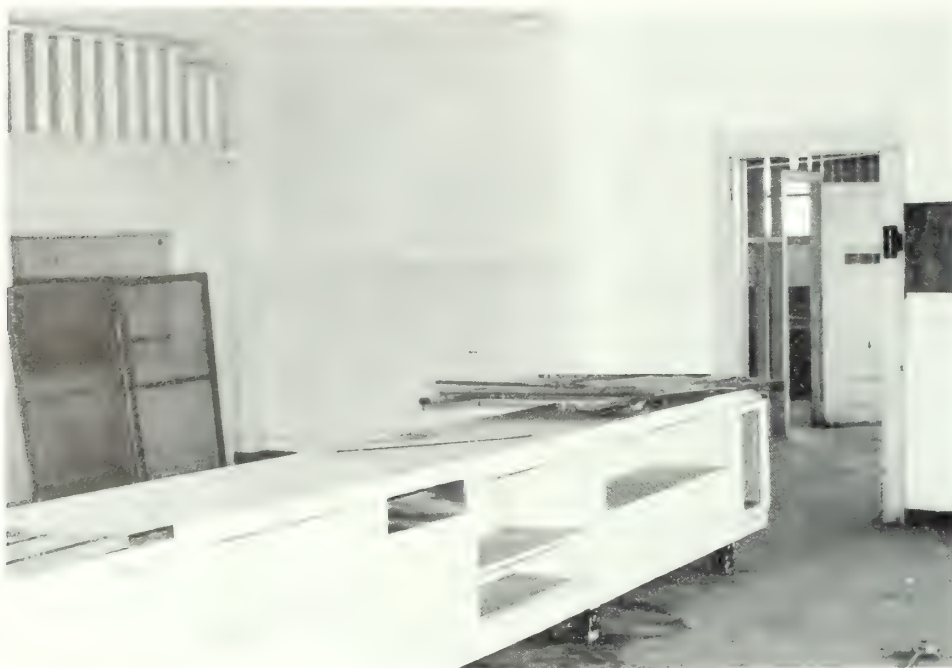
Photo 62: Lunch Room, view toward southeast corner, with 1949 lunch counter. Photo by R. L. Carper, NPS, 1997.

Lunch Room floors have a black coating which is apparently remaining adhesive for floor tile installed probably in 1955. The original concrete base in the east two bays of the Lunch Room was removed. The floor and base were painted gray in the Kitchen storeroom. The tile adhesive and paint should be removed in these areas and the red concrete floor cleaned and repaired. Some of the slab joints in the lobby and Lunch Room have separated. These joint separations should be cleaned and grouted. At any existing plumbing and electrical penetrations in the floor that will be removed, patch the remaining holes.

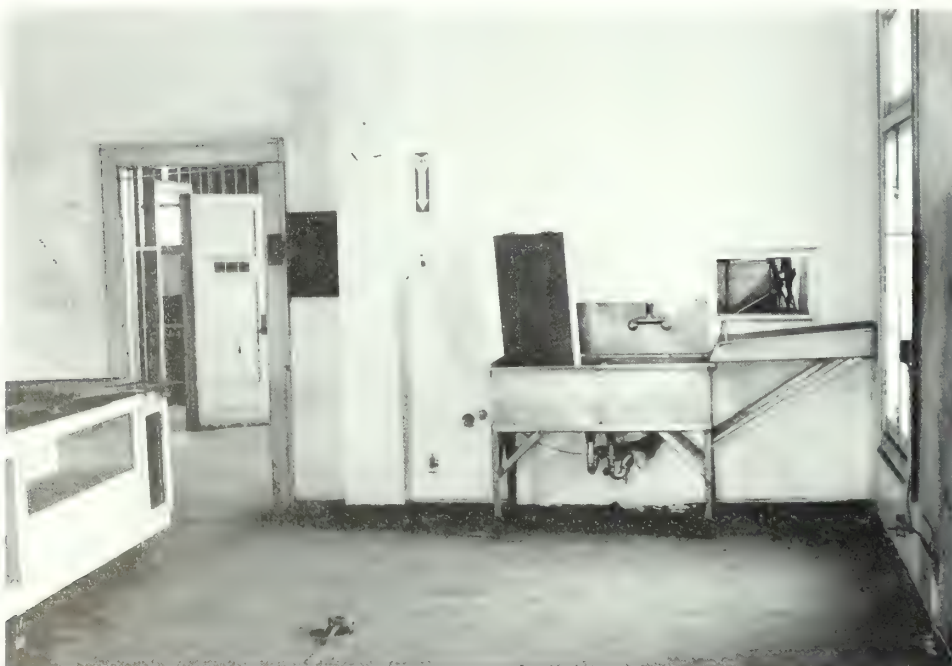
Photo 63: Northwest corner of Lunch Room. At left is part of the 1972 and 1981 partition that separated the Lunch and entry; the doorway to the kitchen was changed in 1949. Photo by Gordon Chappell, NPS, November 13, 1996.

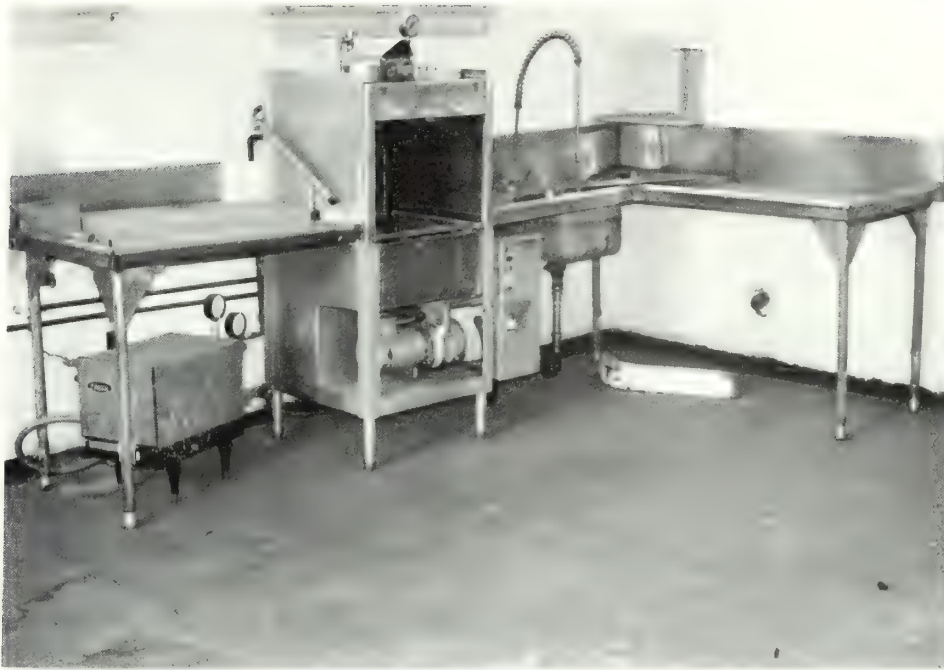
Photo 64: Northeast corner of Lunch Room. Photo by Gordon Chappell, NPS, November 13, 1996.

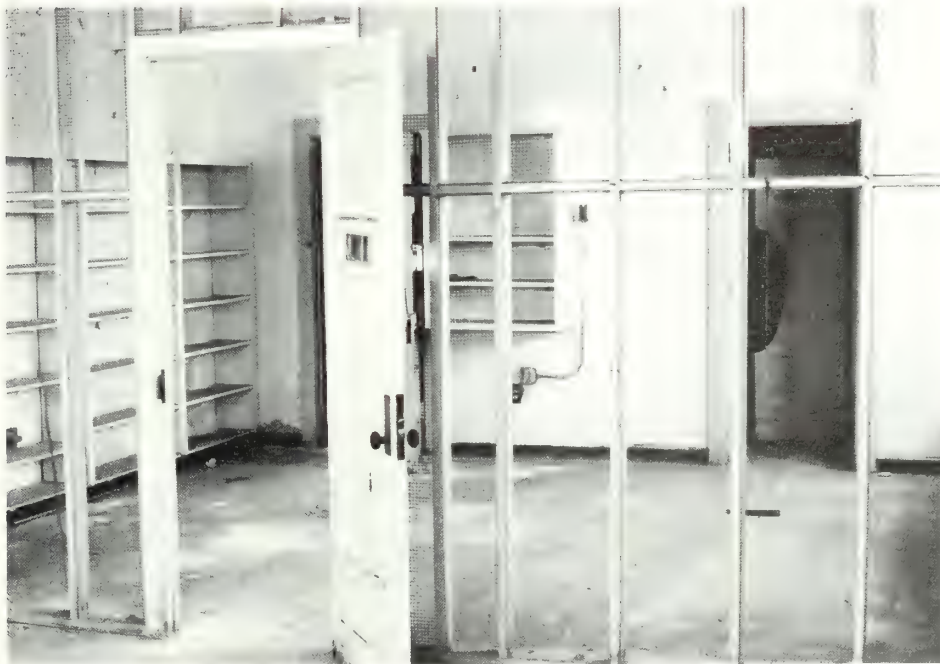
Photo 66: Stud and wire mesh partition in kitchen, installed in 1955. Photo by Gordon Chappell, NPS, November 13, 1996.

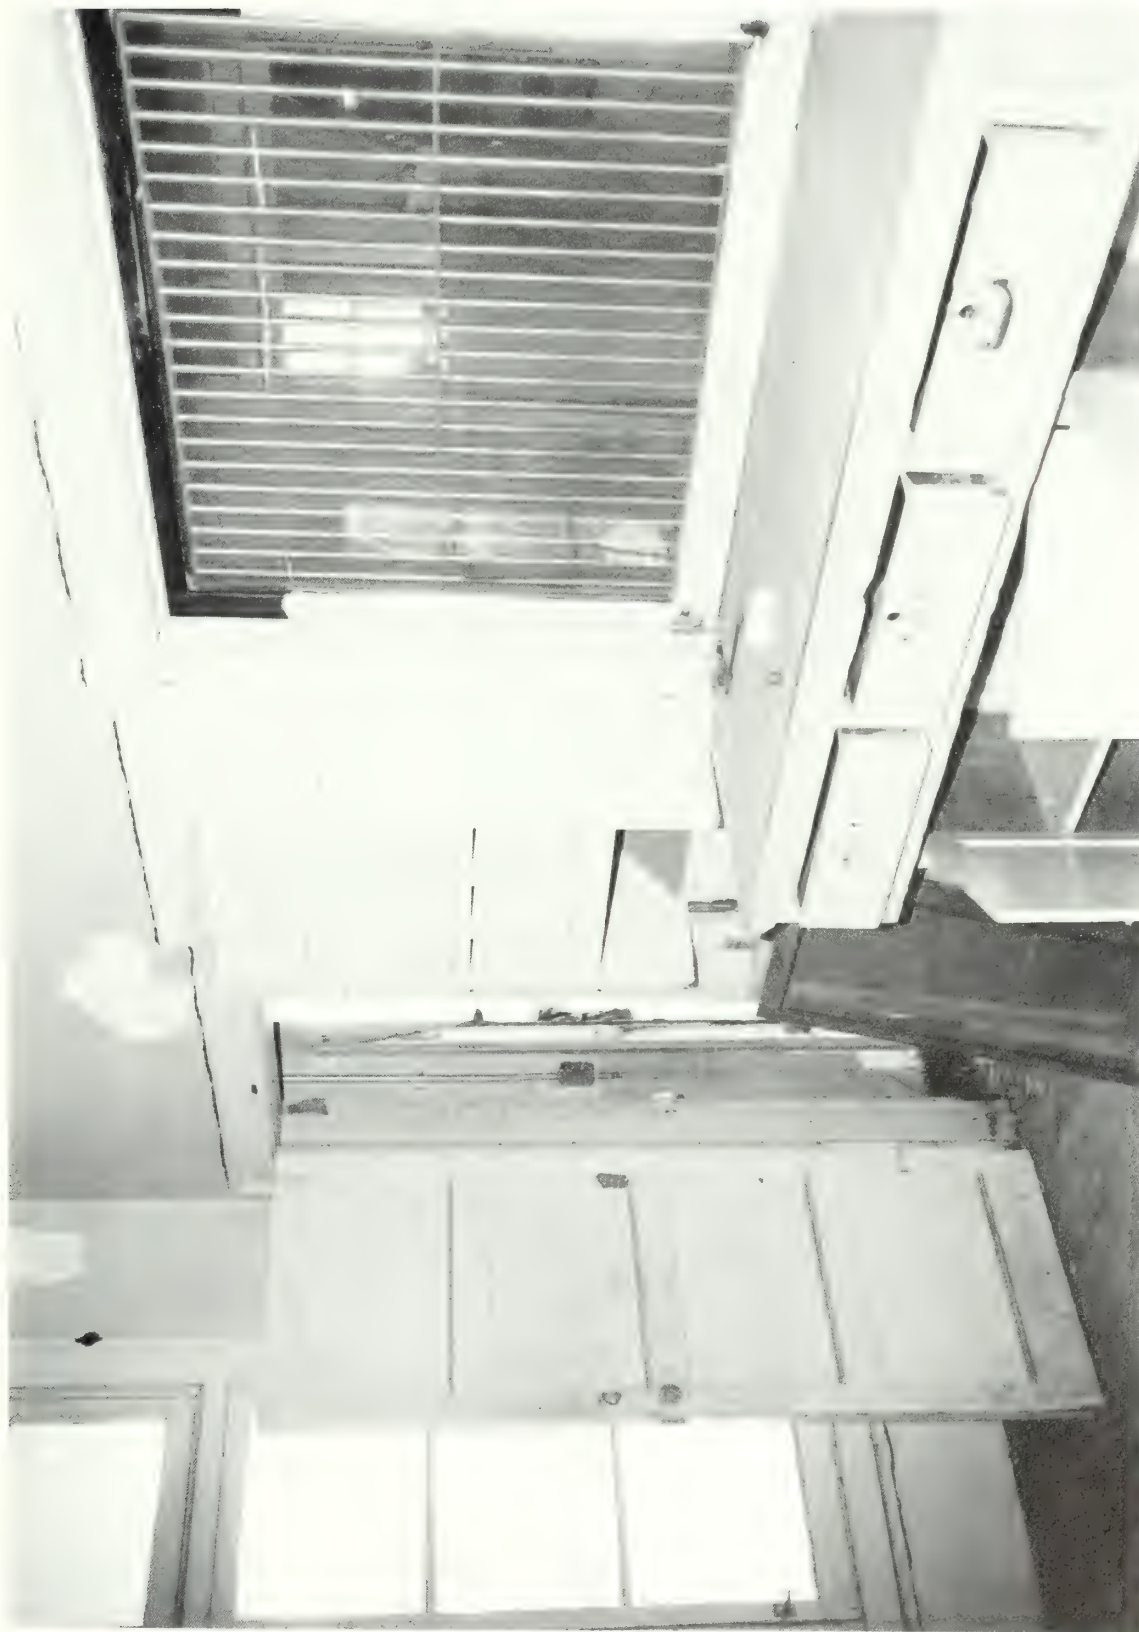
Ticket Office: The plastered ceiling and walls are painted. Paint and the plaster finish coat are cracked, peeling and spalled (approximately 40%); there are diagonal cracks in the north wall from the upper east corner to the lower west corner. The existing paint scheme consists of a blue wainscot to 5 feet above the finish floor, with salmon above and a tan ceiling. Cabinets and trim are blue. Previous wall paint schemes included brown, over gray, which can be seen in the wainscot portion at missing cabinets. The concrete floor, with the 12 inch square scored pattern and concrete molded base, are both red.

The original ticket counter remains in the west wall. The original ticket window was converted into a compartmented information box for the trainmen and a new window installed to the north of the original. At the north end of the counter, a 90 degree rotating pass-through was also a later addition. In the center of the east wall, a varnished wood train schedule board remains. The counter and window assembly and the east wall train schedule board are recommended to be preserved and restored in their present form as part of the interpretive scheme. The interior sash, frames and trim of the large window in the south wall, as previously described, are all in fair condition. The original lighting may or may not be represented by the three extant ceiling mounted porcelain lampholders with bare lamps.

Photo 67: Interior of Ticket Office. Doorway leads to Conductor's Room. Photo by Thomas D. Mulhern, Jr., NPS, April 2, 1996.

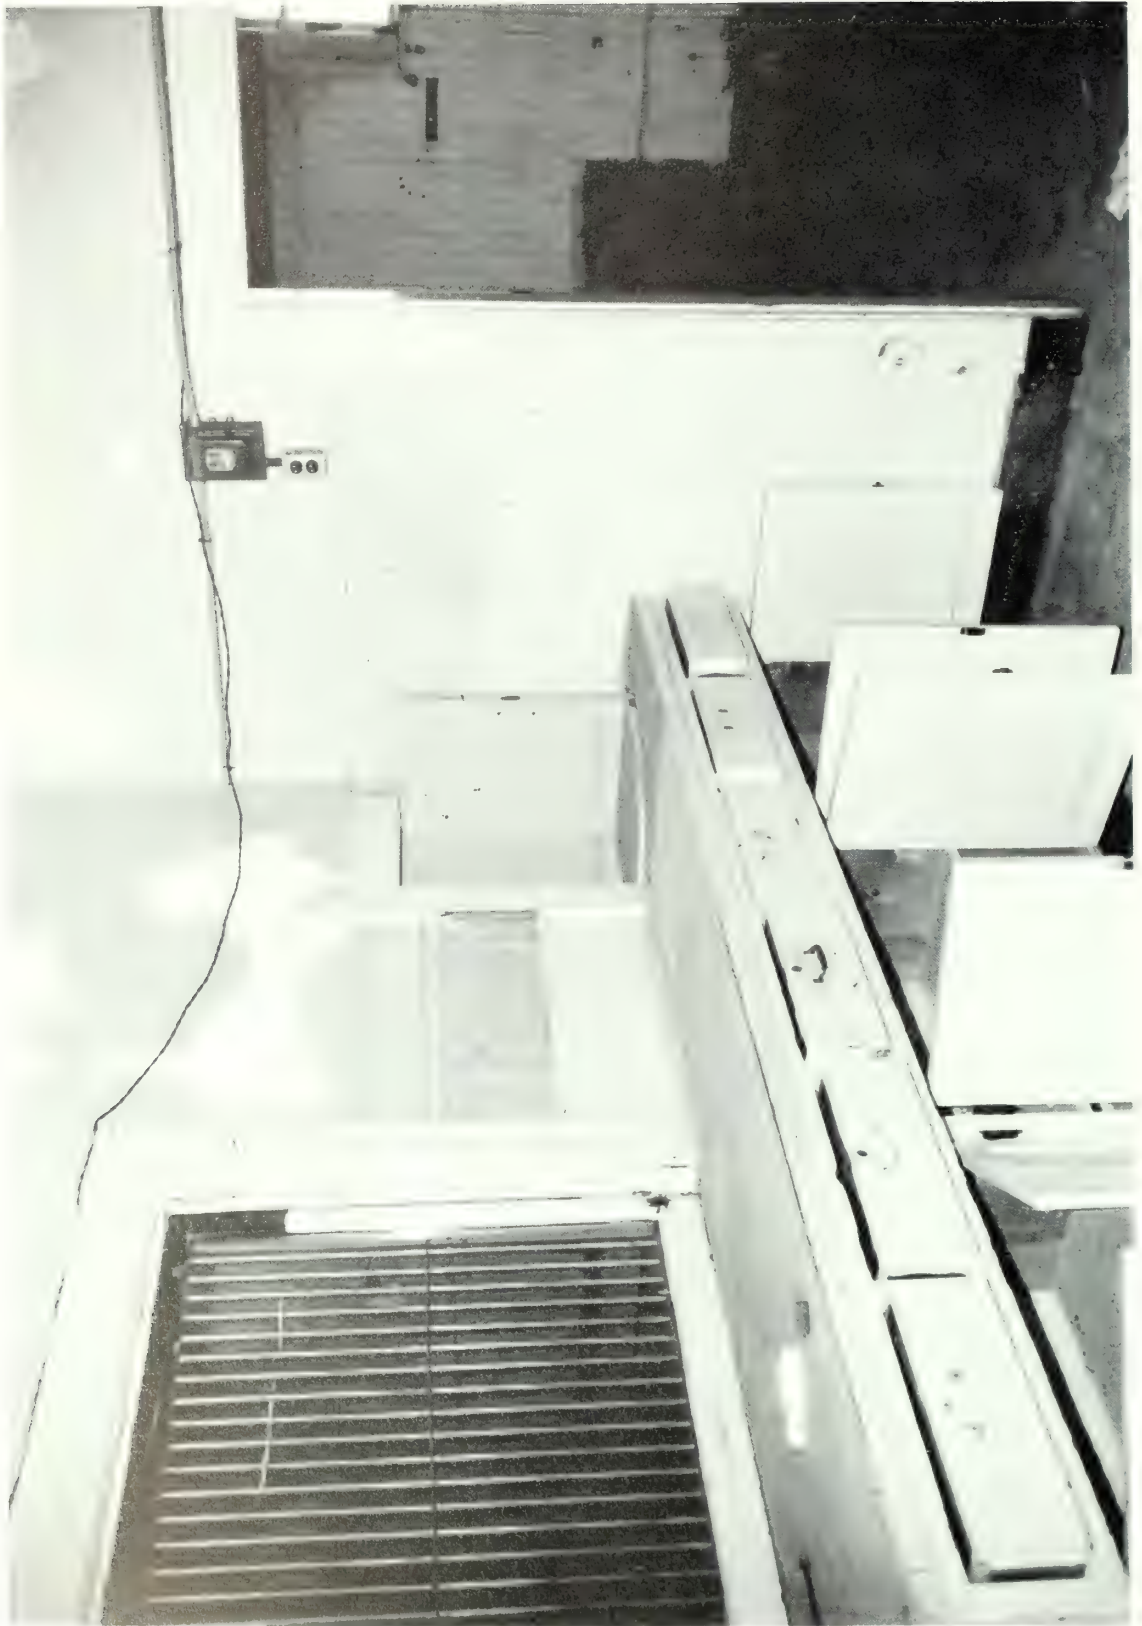
Photo 68: Interior of Ticket Office. Doorway at right leads to the Baggage Room. Photo by Thomas D. Mulhern, Jr., NPS, April 2, 1996.

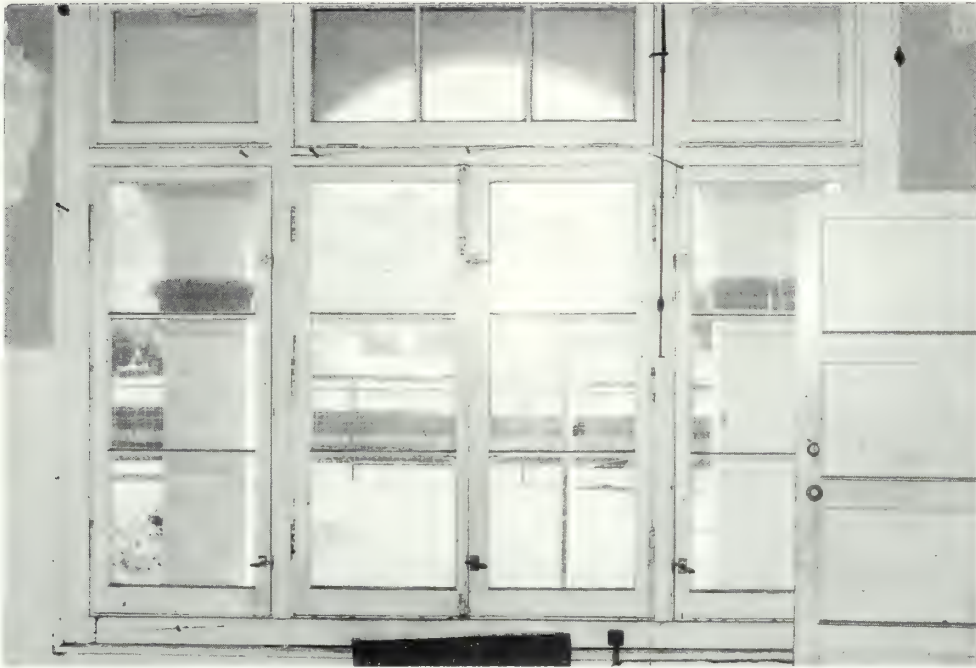
Photo 69: Ticket Office window. Photo by R. L. Carper, NPS, 1997.

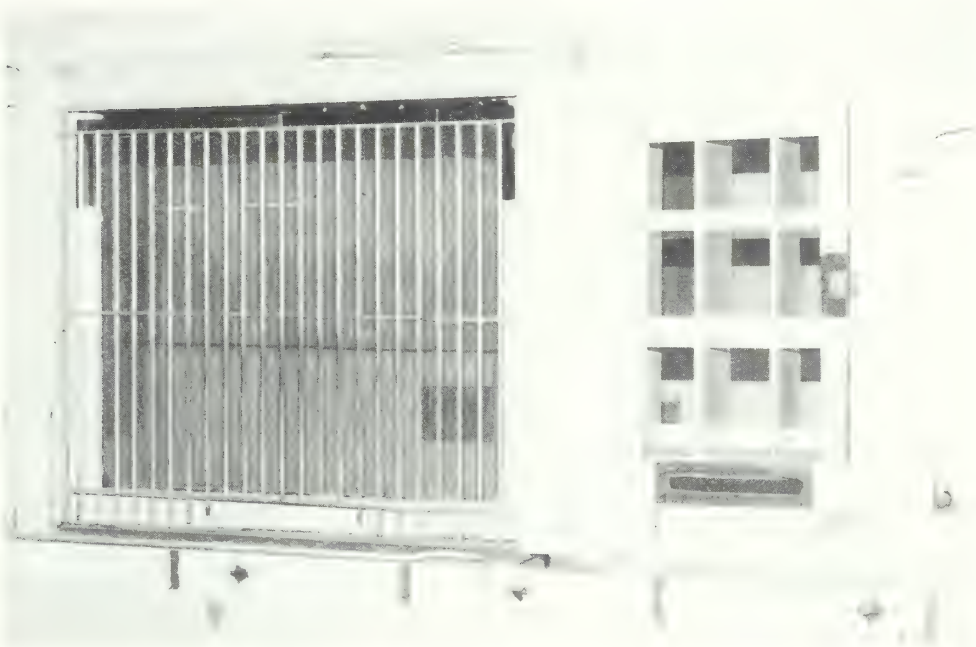
The 1924 as-built drawings show a bench at the west wall and a writing shelf under the Ticket Office window. The bench was moved outdoors to the arcade in later years, but no longer exists. The writing shelf was replaced with a later one extending to and along the north wall. The shelf and all but two wood support brackets are missing at the east wall. Not shown on the original drawings in the north wall is a small pass-through window (24 x 27 3/4 inches) to the Baggage Room. The sash is a vertical sliding unit; the glass is missing. The later Ticket Office window in the east wall has a steel grill; the glazing is intact.

Photo 70: Ticket Office window at Conductor's Room side. Photo by R. L. Carper, NPS, 1997.
